MEADOWDALE BEACH PARK AND ESTUARY RESTORATION EFFECTIVENESS MONITORING Year 1 Report

Prepared for
Snohomish County
Surface Water Management

December 2023
Revised June 2024

Meadowdale Beach Park and Estuary Restoration

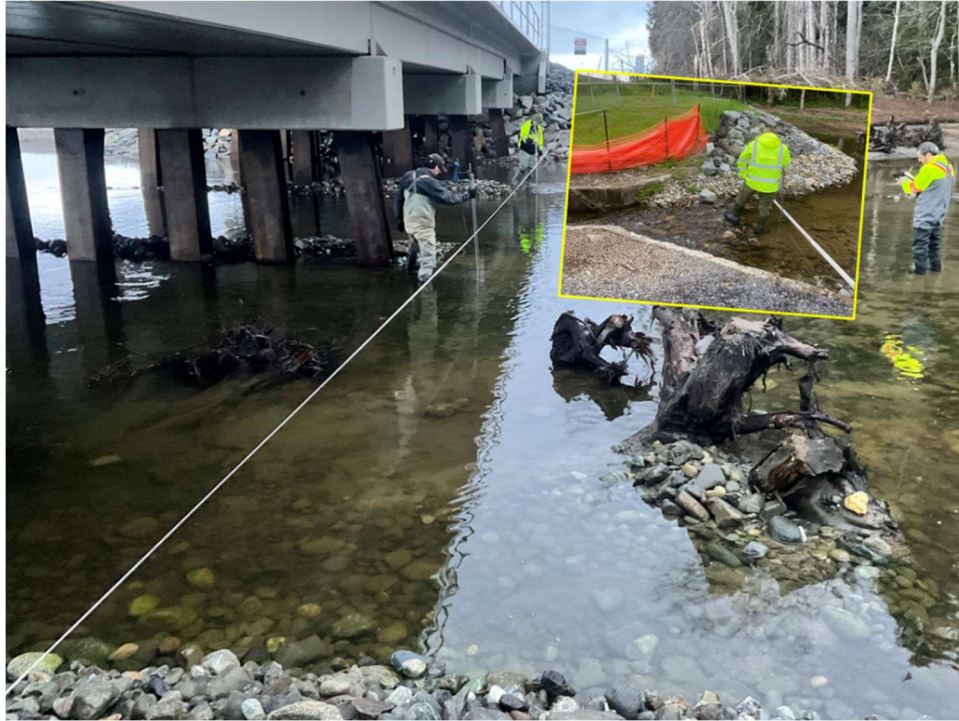
Figure 3. Post-Restoration Velocity Measurement Location at Upstream Margin of Bridge During High Tide with Inset Photo of Pre-Restoration Location

The year 1 post-restoration flow velocity was measured January 25, 2023, when tide height was predicted to be highest within one year after construction. Flow velocity was measured across a transect spanning the channel at the upstream margin of the railroad bridge. **Figure 3** shows the transect at high tide and **Figure 4** looks upstream to the transect at low tide. Flow velocities measured at 20 stations never exceeded 2.0 feet per second, as seen in **Figure 5**. The maximum observed velocity was 1.562 feet/sec, substantially less than velocities observed in the original culvert. Velocity across the wetted width of the channel was highly variable as well, as flow also was unequally distributed between the three bridge spans/supports. Velocity increased as the tidal stage dropped, as flow become more localized between the three primary flow pathways (between bridge supports), and as stream flow began to dominate the total flow volume, which was true after the tide receded downstream of the channel cross section (see **Figure 4**).

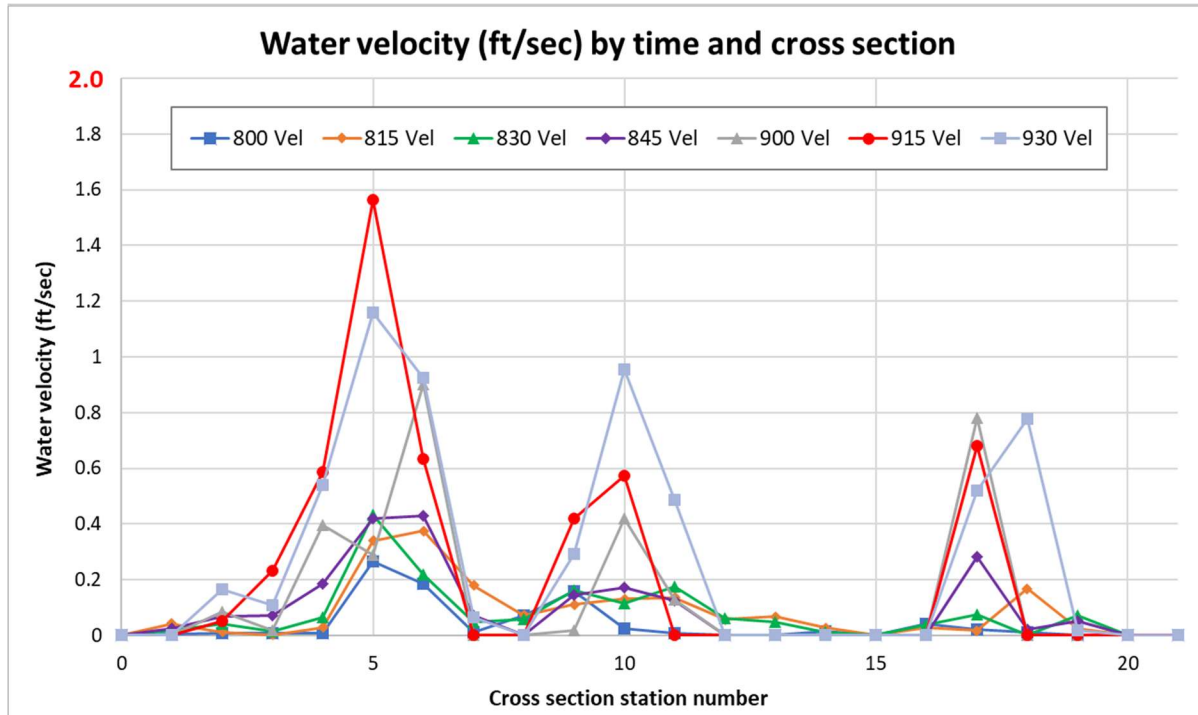
Figure 5. Post-Restoration Flow Velocities Measured in 15-Minute Intervals from High Tide (8:00 am) to Until Only Stream Flow Was Present (9:30 am)

Fish passage conditions to the restored estuary were evaluated based on the velocity criteria in the Washington Administrative Code (WAC) 220-110-070 and WAC 220-660-200. This criterion is referenced in the WDFW draft guidance for evaluating fish passage at tidally influenced culverts (WDFW 2020). The length of the new bridge crossing is approximately 35 feet. Per the WAC and WDFW (2020), for crossings less than 100 feet long, there is no barrier to fish passage until flow velocities exceed 4 feet per second. Post-restoration flow velocities never exceeded 2.0 feet per second; therefore, the velocity performance standard was achieved.

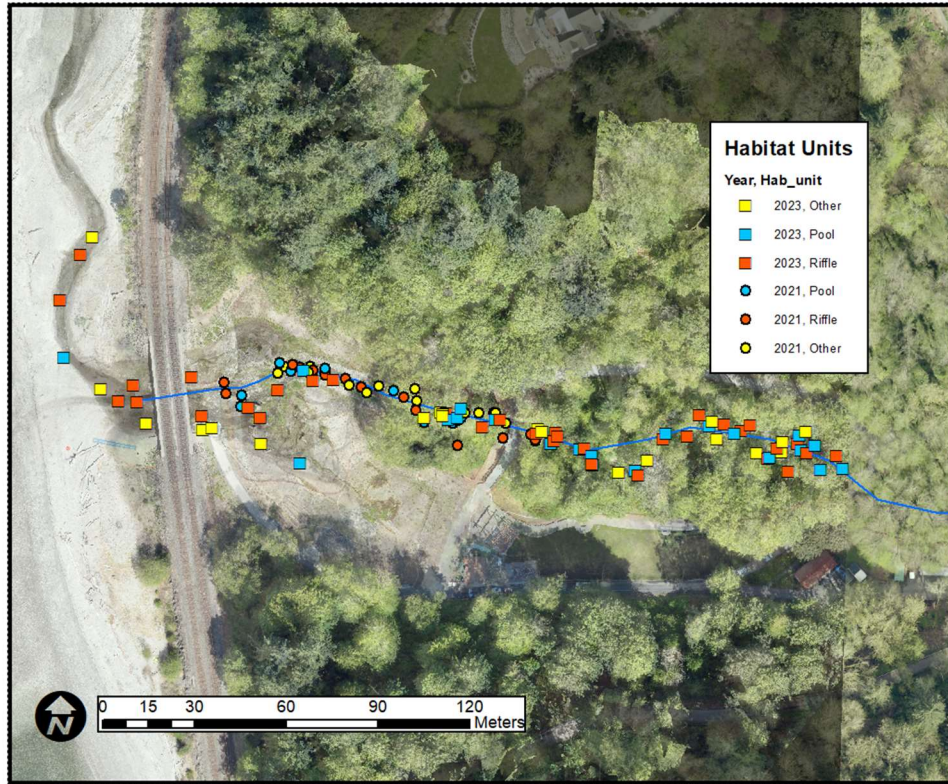
Figure 12. Map of 2021 and 2023 Habitat Unit Survey by Year and Habitat Type

The pre- and post-restoration habitat mapping is presented in (**Figure 12**). This part of Lund's Gulch Creek overlapped with the new estuary embayment design, which included excavation to establish tidal inundation. Hence, pre-project monitoring in 2021 was implemented in a stream segment with a pool-riffle planform, whereas in 2023 this same segment was steeper (due to excavation) and geomorphically had intentionally been transformed to an alluvial fan planform that had steeper channel profile and mostly riffle habitat (**Figure 13**). As a result, whereas in 2021, this creek contained 8 pools and approximately 25 percent pool area (**Table 7**), in 2023 this creek segment contains fewer pools and less pool area (**Table 8**). This was by design, and habitat quantities will be evaluated in future years as more channel adjustment occurs.

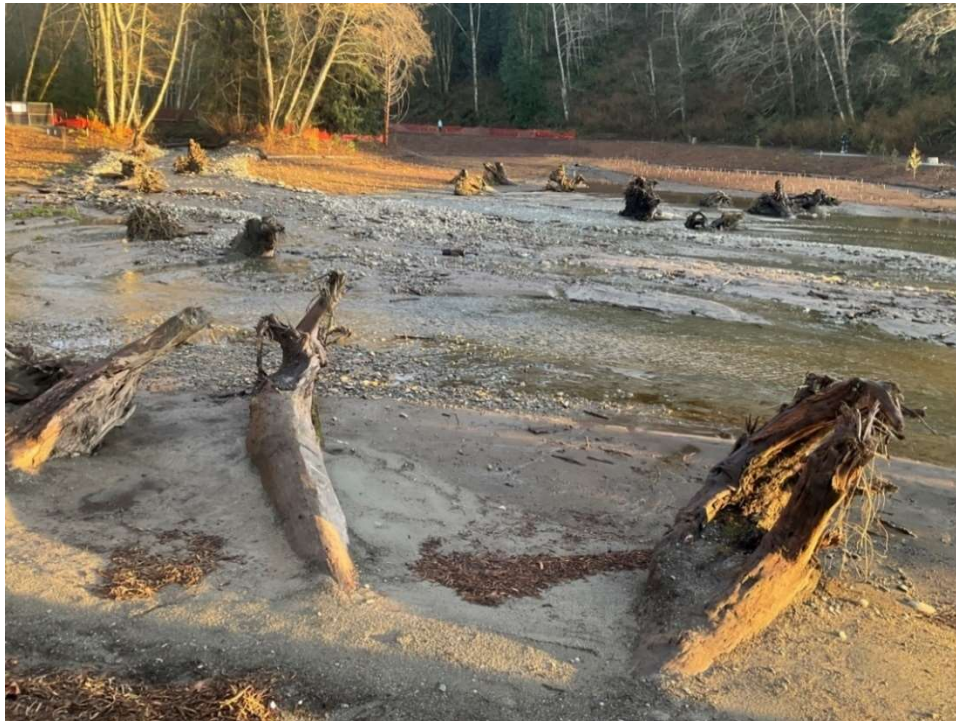
Figure 13. Lund's Gulch Creek Excavated Embayment Area Looking Upstream Toward the Creek Mouth

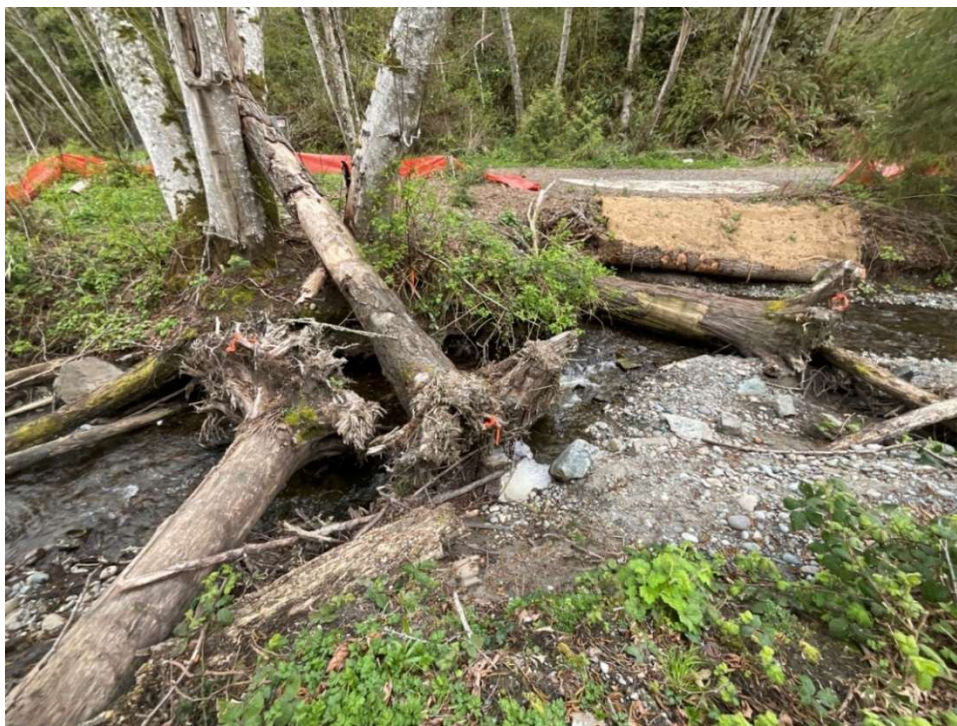
Figure 16. Large Woody Material (flagged) with Rootwads Placed in Lund's Gulch Creek Segment 3

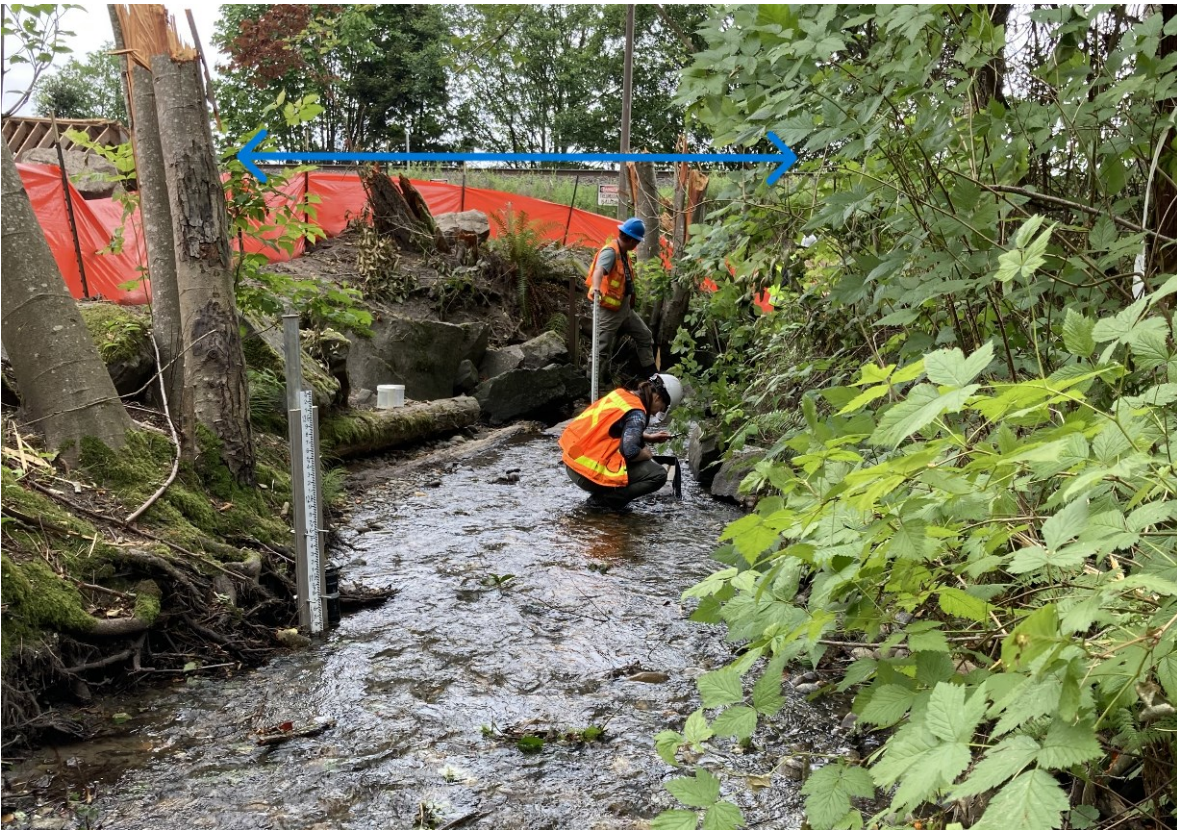
Figure 1. Location 300 upstream from the railroad culvert. Base streambed elevation is 10.6 ft (NAVD88). The rail line is immediately below the Blue arrow in the background (for reference).

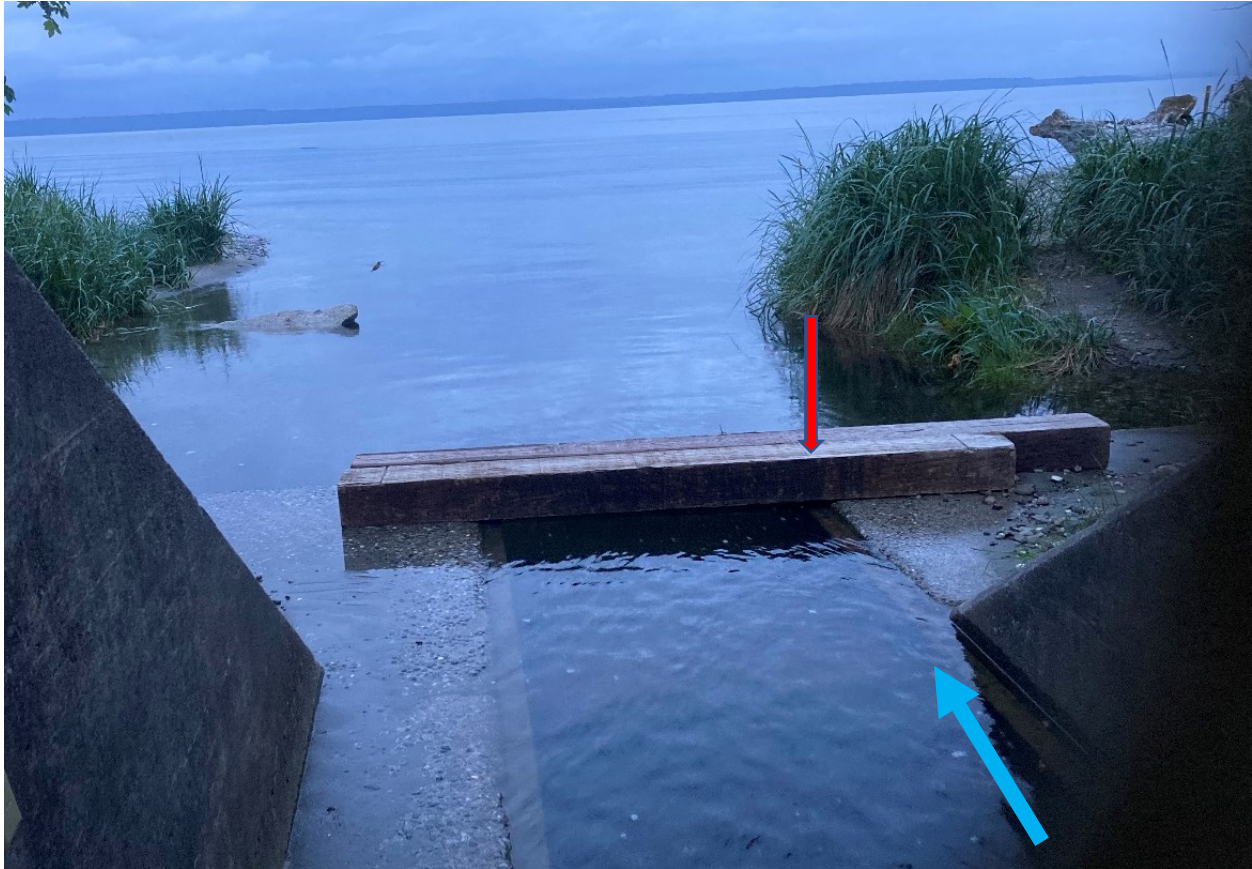
Figure 2. Outlet of the backwatered Lund's Gulch Creek culvert (under BNSF railroad) at high tide May 17, 2022 (11.00 ft. MLLW, 5:14 AM). Puget Sound is in background. Stream flow direction is shown with blue arrow. The red arrow shows the location of the downstream staff gauge, also shown in Figure 3.

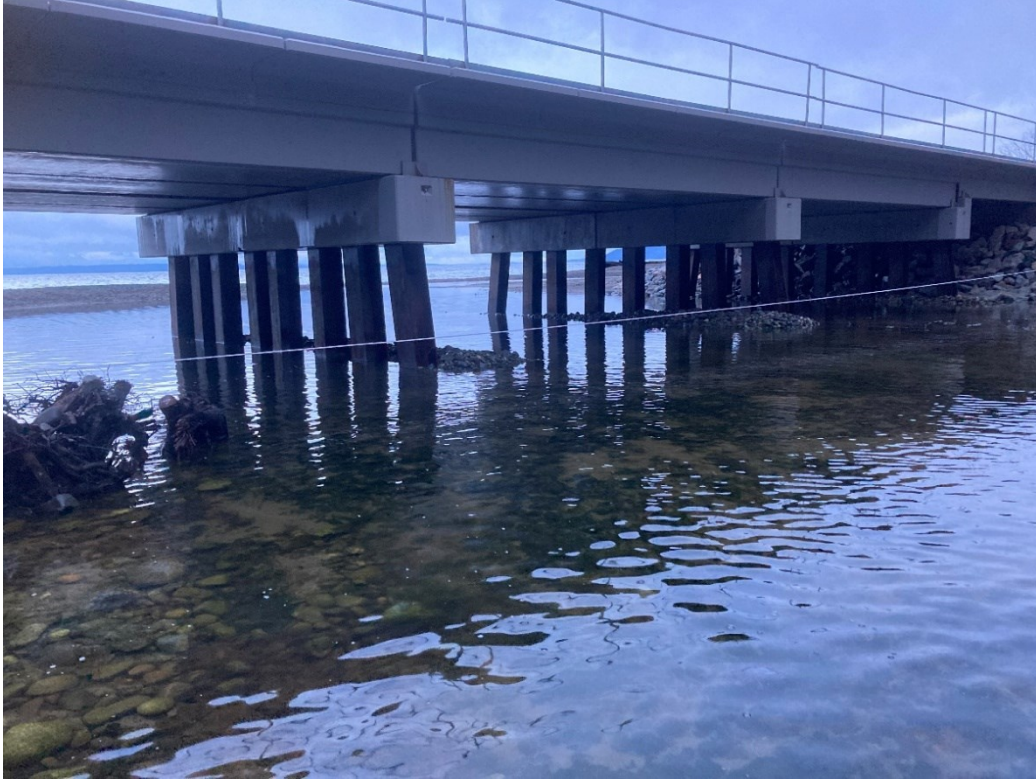
Figure 8. Tidal inundation upstream of the former railroad culvert, January 25, 2023. Predicted tidal elevation was 12.54 ft MLLW, though actual tidal elevation was estimated to be 11.63 ft MLLW based on gauge data. The NAVD elevation recorded on the staff gauge was 9.6 feet.

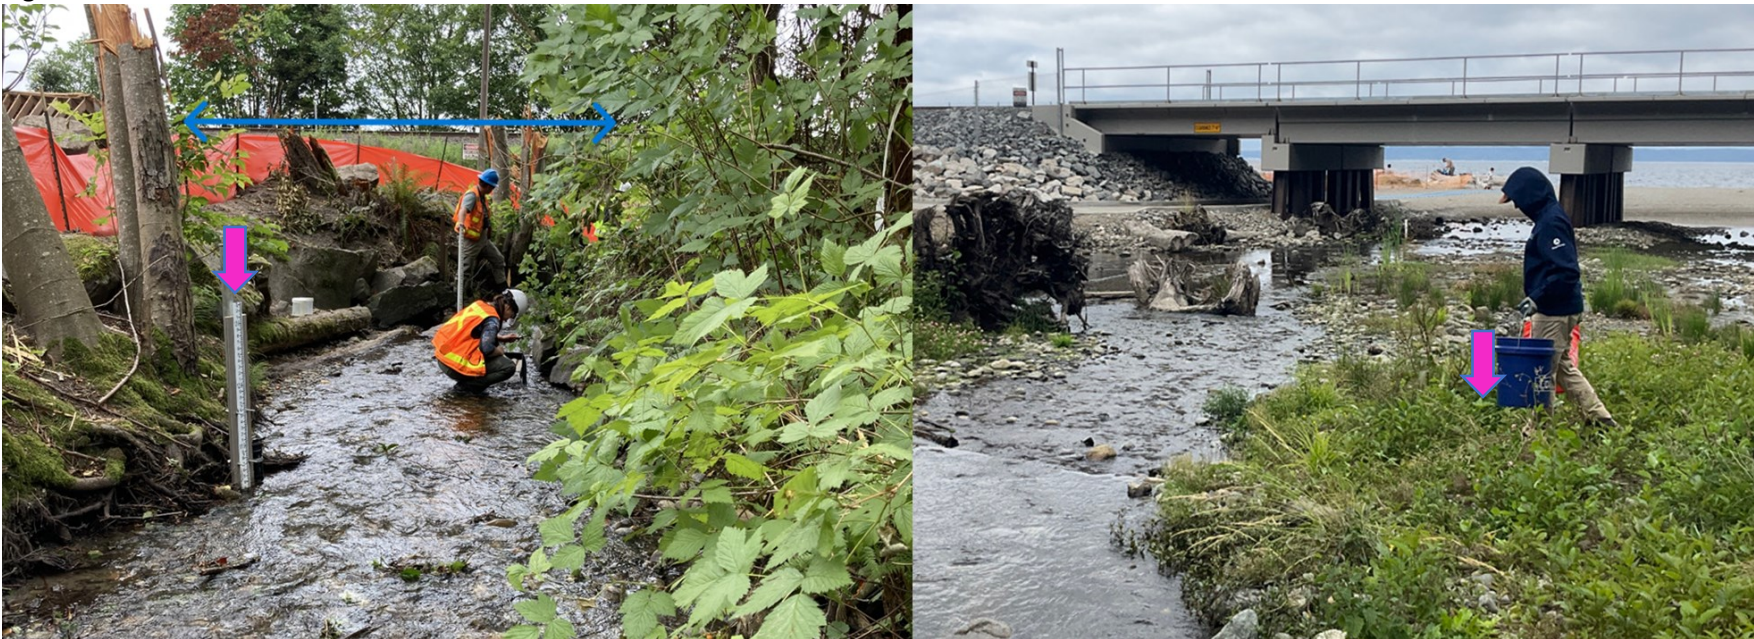
Figure 15. 2021 and 2023 images of Location 300 (pre-project hydrograph) in left image and estimated location in right image. No longer in stream line.

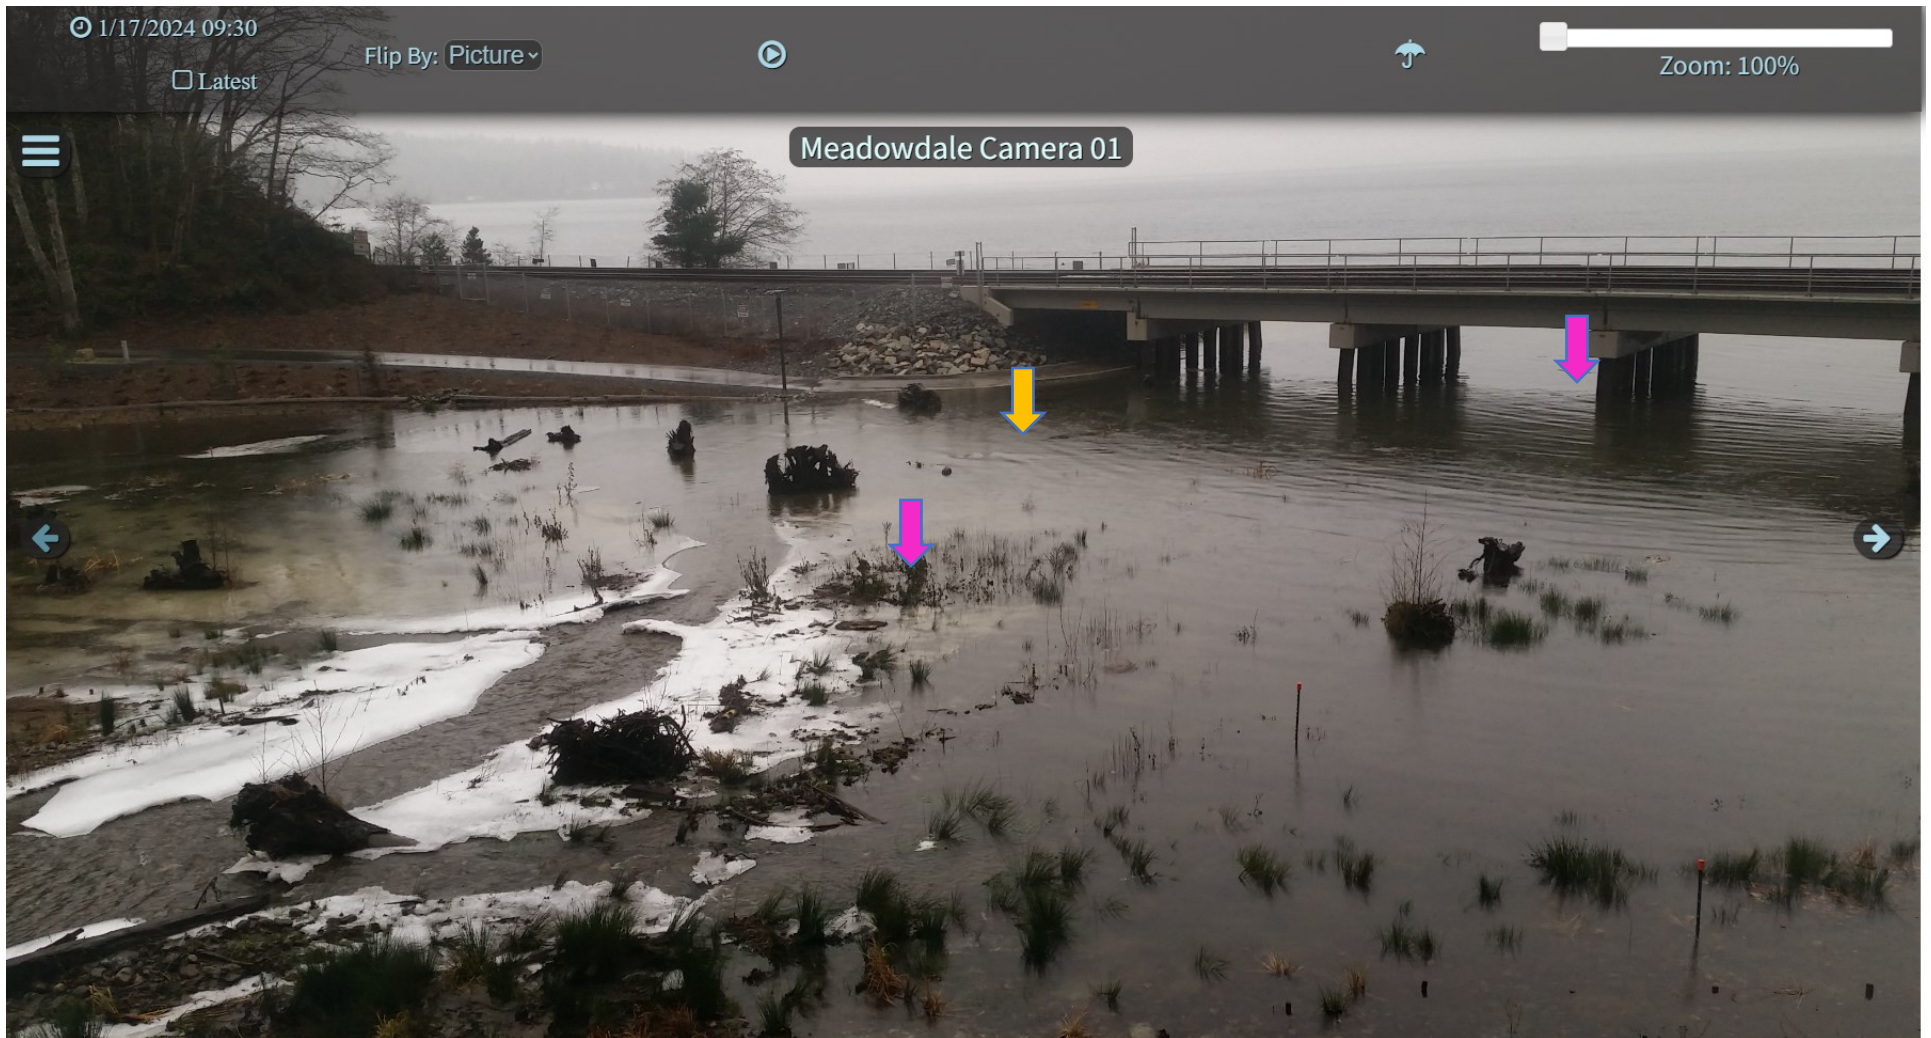
Figure 16. Maximum photographically observed tidal elevation (12.36 ft. MLLW) on January 17, 2024 demonstrating tidal inundation and pocket estuary habitat area. The approximate location s of the 2021 (Magenta) and 2023 (Orange) hydrographs are shown. Daily imagery is available at: [Sensera Public View \(senserasytems.com\)](https://senserasytems.com)
