# MEADOWDALE BEACH PARK AND ESTUARY RESTORATION EFFECTIVENESS MONITORING Year 2 Report

Prepared for  
Snohomish County  
Surface Water Management

April 2025

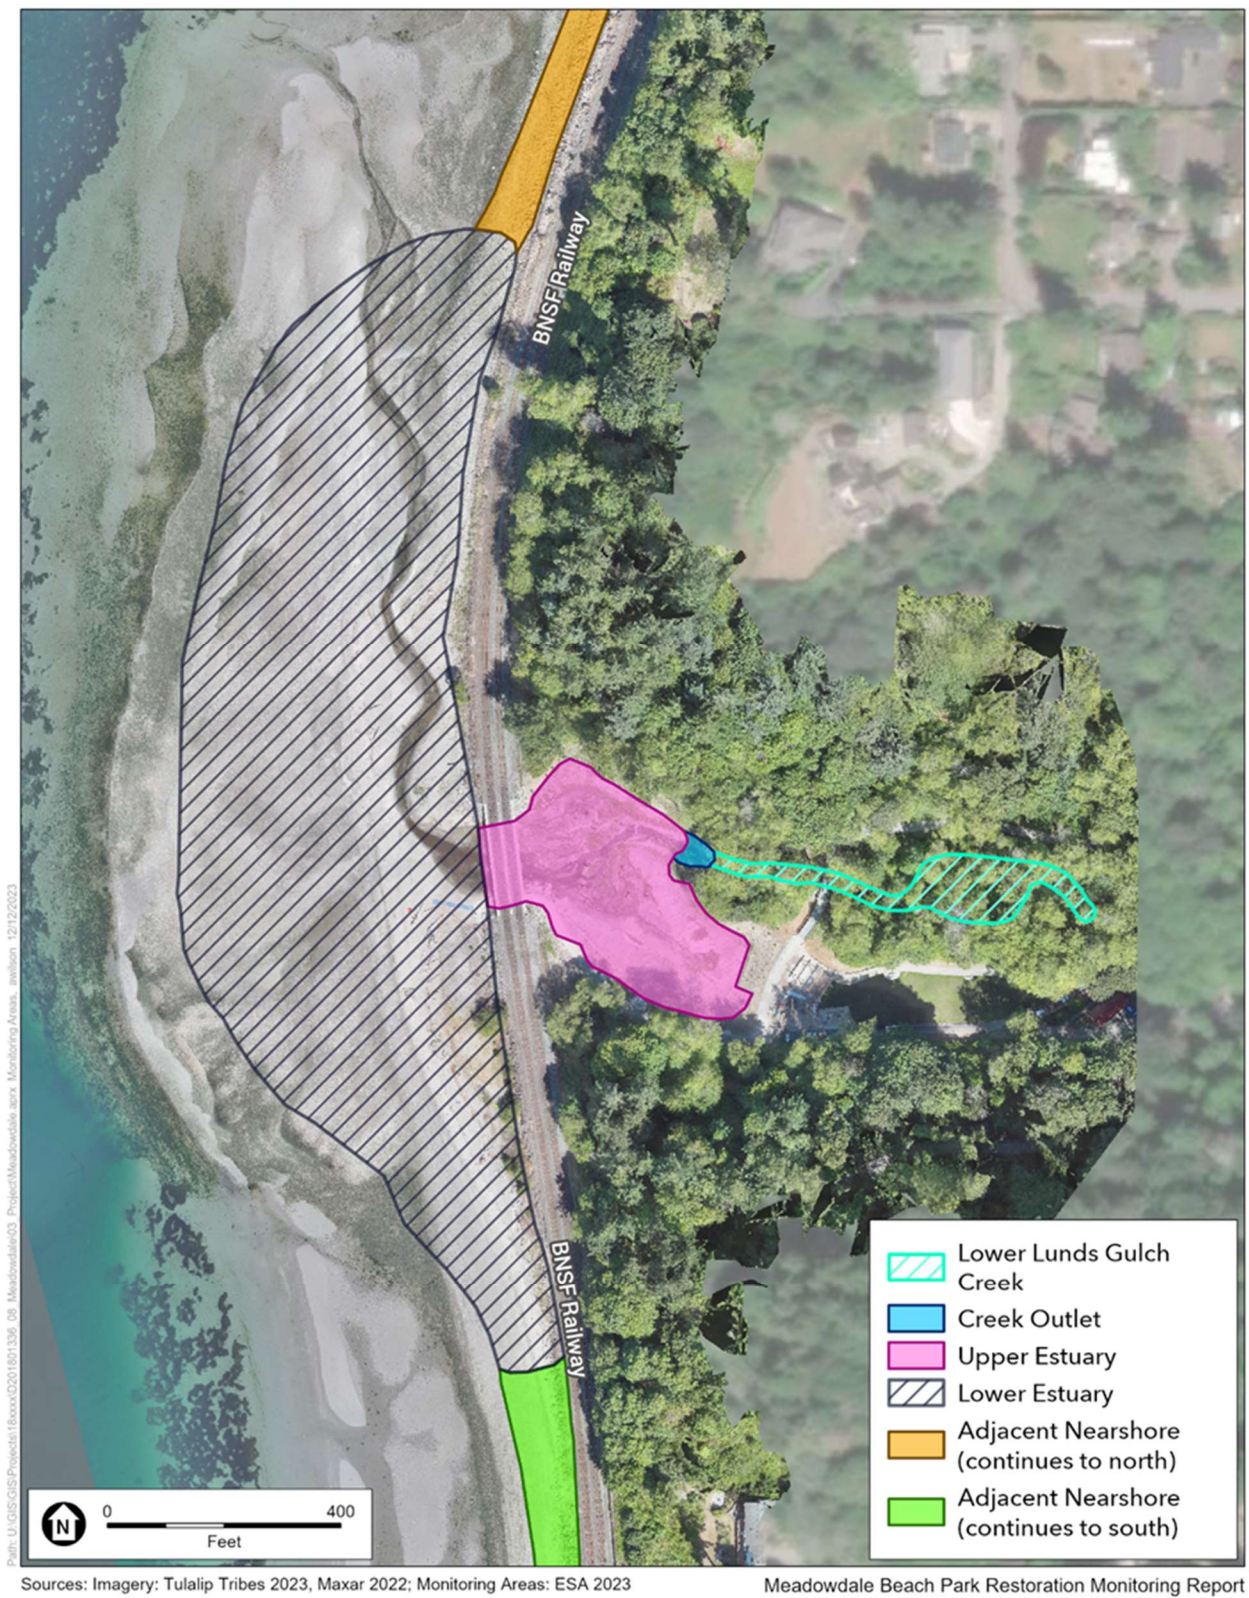
The monitoring plan includes monitoring activities in five distinct areas. From upstream to downstream, the monitoring areas are defined as follows and shown in **Figure 1**:

- **Lower Lund's Gulch Creek** – Portion of the stream where restoration occurred; the upstream end is the pedestrian bridge near the park ranger's house.
- **Creek Outlet** – Transitional area where the creek widens as it enters the restored upper estuary.
- **Upper Estuary** – Restored tidal estuary landward of the railroad, including the area under the railroad bridge.
- **Lower Estuary** – Estuary waterward of the railroad bridge and including the entire shoreline delta.
- **Adjacent Nearshore** – Adjacent areas north and south of the project area.

These areas are outlined on the map to generally show the boundaries of each monitoring area. These delineations are not strict outlines of the extent of sampling. For example, vegetation monitoring in the upper estuary may extend outside of the outline shown in **Figure 1**.

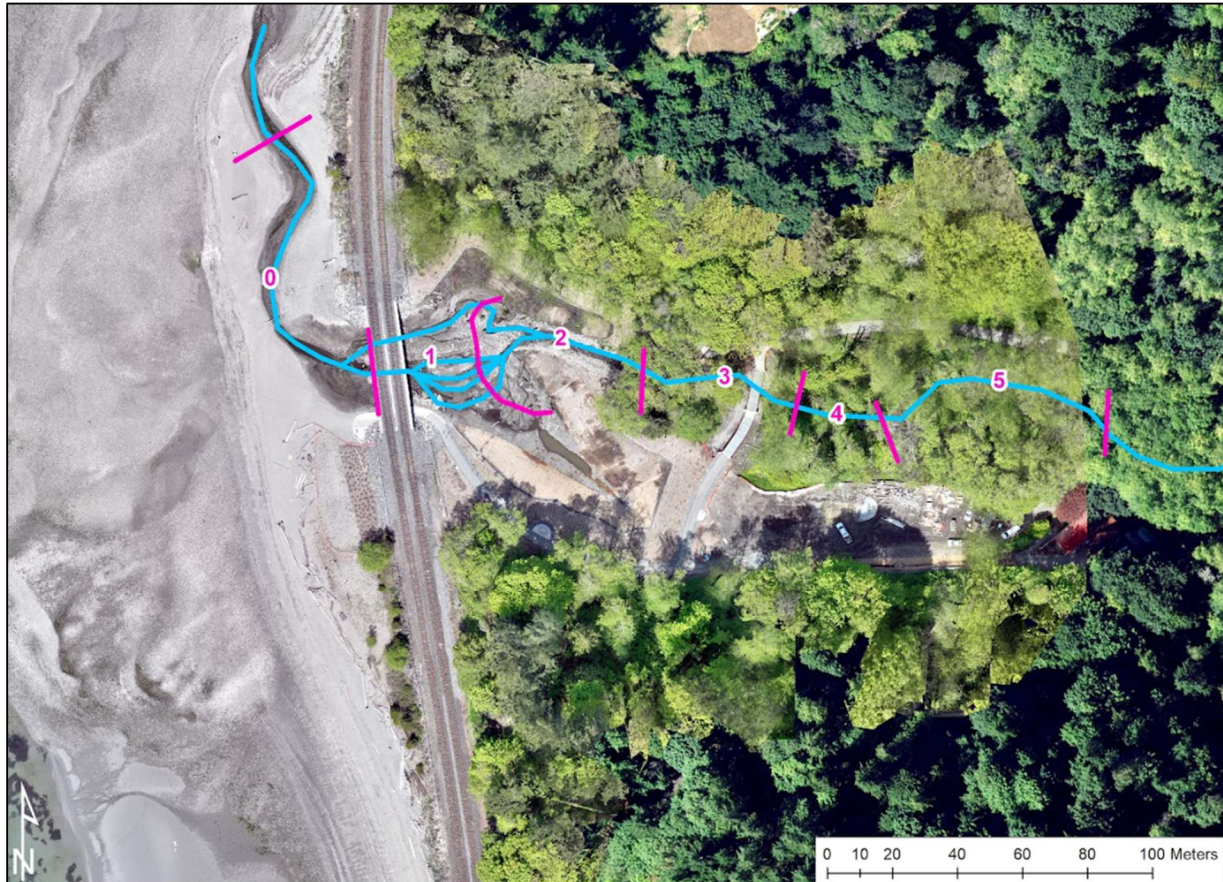
Six consecutive stream segments (0-5 in Figure 1) were defined for the project area and are utilized as part of electrofishing, are geomorphically and tidally distinct, and were surveyed as part of habitat inventory and assessment. Stream segments are described in Table 1, and habitat survey work that overlaps these segments is denoted. Habitat Survey segments are also shown in Figure 1.

**Figure 1. 2023 Lund's Gulch Creek stream survey segments.**

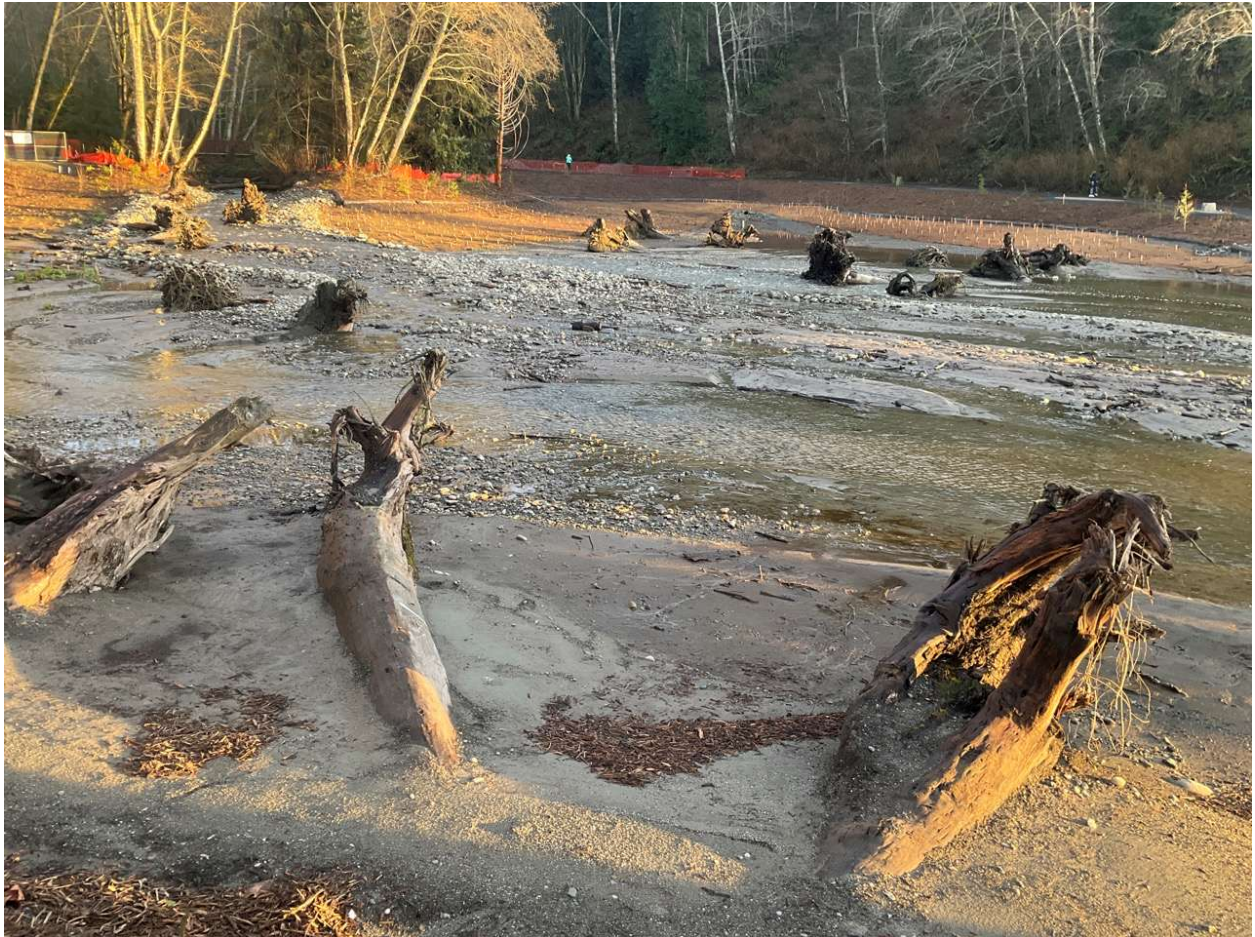
**Figure 3. Lund's Gulch Creek excavated embayment area looking upstream toward the creek mouth (with trees), the alluvial fan with riffle habitat in creek segment 2, with large woody material placed in the embayment area. Woody material is inundated at higher tidal elevation.**

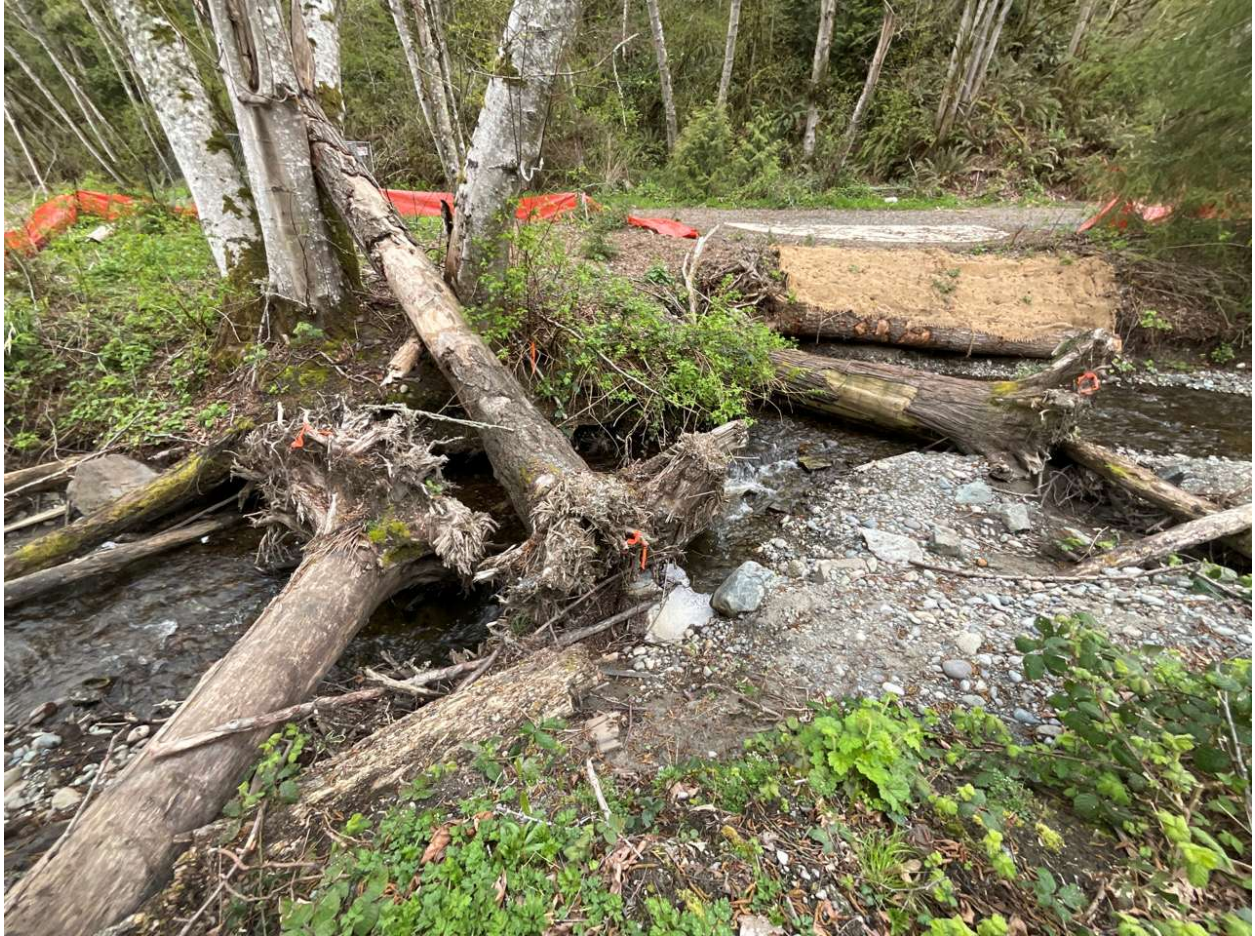
**Figure 7. Large Woody material (flagged) with rootwads placed in Lund's Gulch Creek in creek segment 3.**
