MEADOWDALE BEACH PARK AND ESTUARY RESTORATION EFFECTIVENESS MONITORING Year 1 Report

Prepared for
Snohomish County
Surface Water Management

December 2023
Revised June 2024

Meadowdale Beach Park and Estuary Restoration

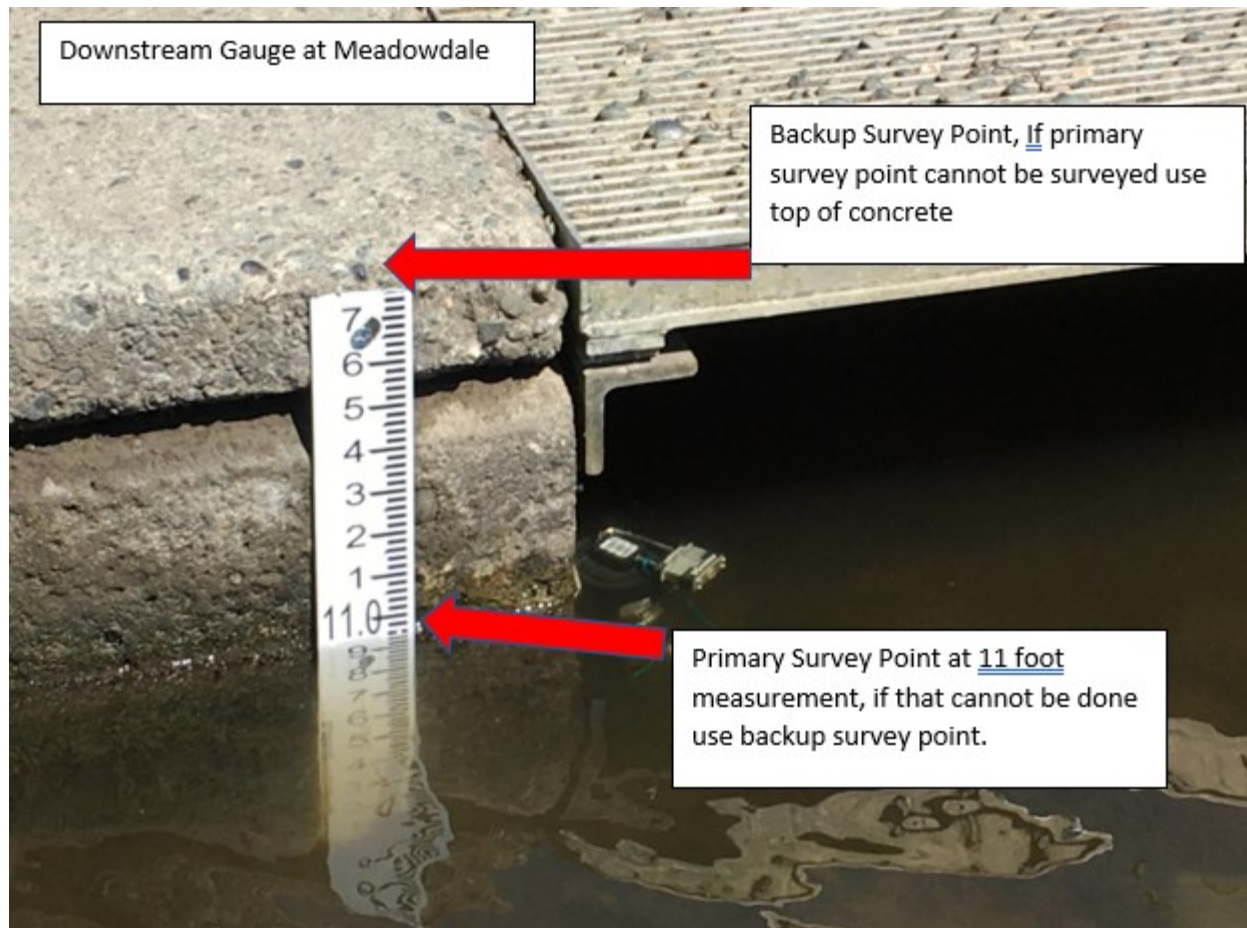
Location zero was subject to tidal influence, as seen in Figure 2, as higher Puget Sound tides backwatered into the stream culvert. Figure 3 shows the staff plate and gauge affixed to the culvert foundation. The streambed elevation of location zero was 7.2 feet, although the staff plate reading was different.

Figure 3. Location 0 staff plate and water level sensor affixed to the railroad culvert in 2021 prior to project initiation.

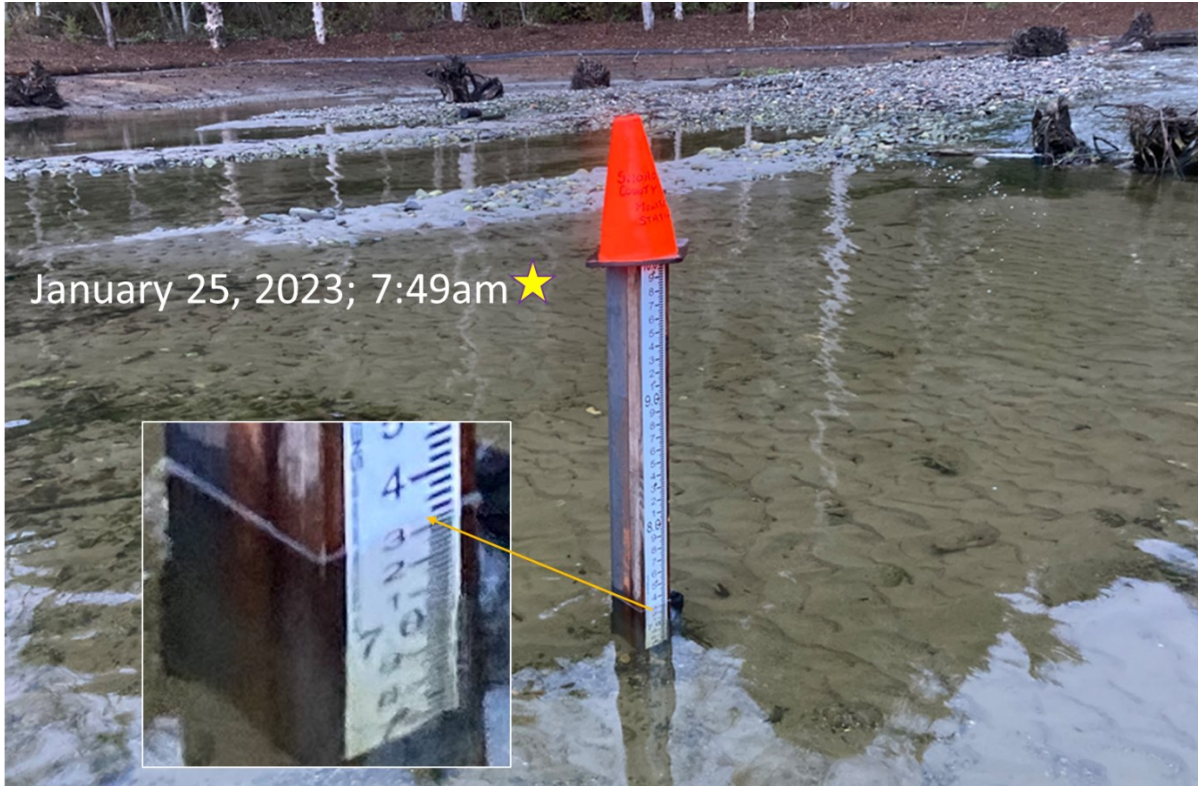
Figure 4. shows an image of the post-restoration hydrograph location in the restored embayment that is tidally backwatered to a staff gauge elevation of 7.33 ft on the staff plate. This staff plate reading was corrected relative to a known elevation benchmark.

Figure 4. Post-restoration hydrograph placement in the restored embayment located on the upstream side of the new railroad bridge.

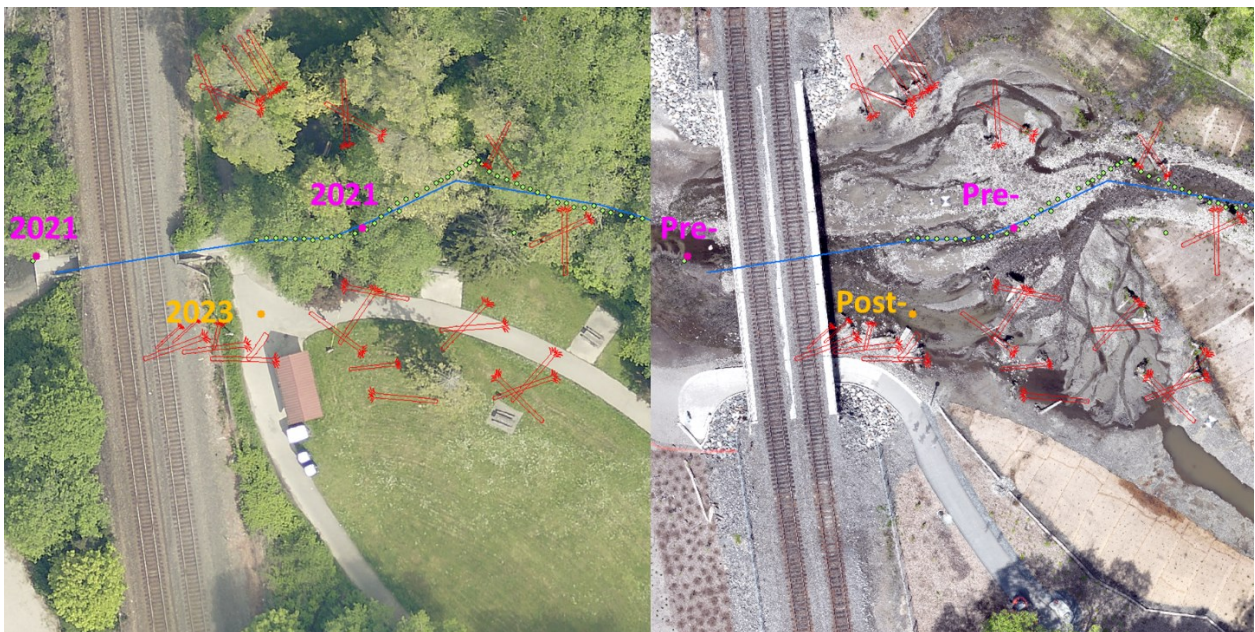
A map-based depiction in Figure 5 shows the staff gauge and water level sensor placement in 2021 and 2023 with respect to both a pre-project image (left, Figure 5) and a post-restoration image (right, Figure 5). Note that in 2023 there is only one sensor that was placed on the upstream side of the new railroad bridge shown in Figure 5. As shown in Figure 2, the pre-project gauge location is fully inundated by tides in Puget Sound. Hence, with restoration, the project monitoring question is with respect to tidal inundation and elevation within the restoration area. The location of the 2023 post-project hydrograph was actually paved and at a higher surface elevation of approximately 12.1 foot elevation (NAVD88). For tidal measurement comparison, we estimate the 12.1 foot elevation is equivalent to the tidal elevation 14.38 ft (MLLW, Mean Lower low Water) – higher than the predicted astronomical high tides for nearby Seattle and Everett. Hence, this location would virtually never be tidally affected.

Figure 5. Map view of 2021 and 2023 staff gauge locations relative to pre-project imagery (left) and post-project imagery (right).

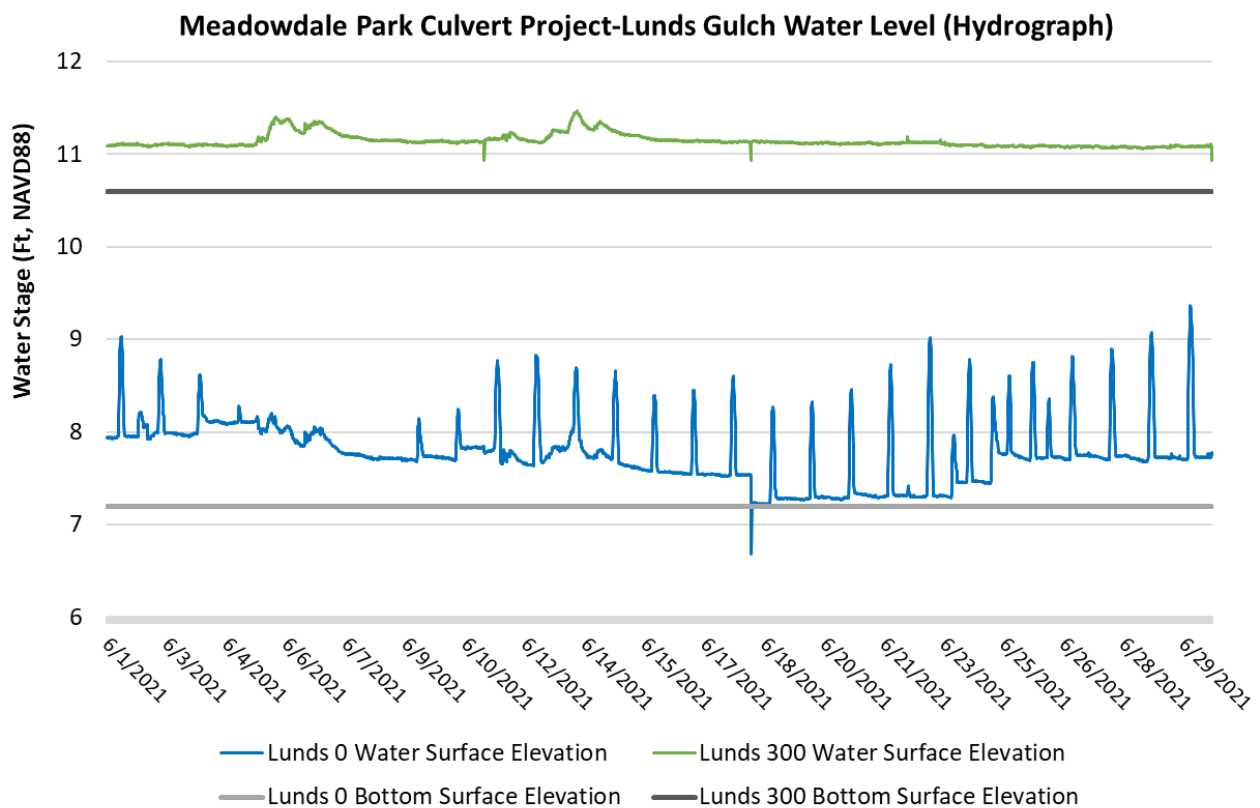
Results are shown in Figure 6 for the pre-project condition spanning one month of time immediately before project initiation. Lund’s Gulch Location 0 is at the lower elevation on the Puget Sound side of the railroad culvert and shows a near-daily high tide spike relative to the daily low flow that is controlled by stream flow. The upper Location 300 is at a higher stream elevation and demonstrates that no tidal inundation occurs. Some fluctuation in the gauge height above the streambed elevation is due to variability in upstream run-off.

Figure 6. 2021 pre-project hydrograph monitoring upstream and downstream of the railroad culvert.

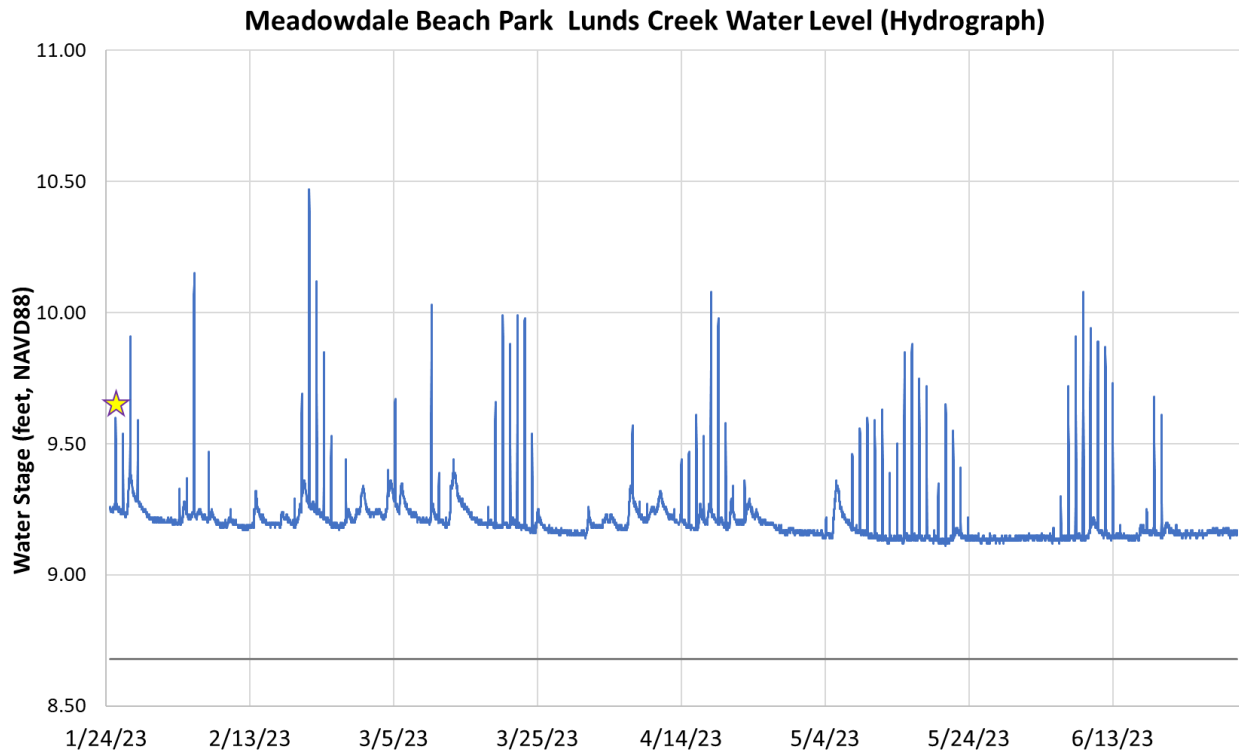
Next, the post-restoration hydrograph was collected over a period of approximately five months between January and June, 2023 and is shown in Figure 7. Many observations of tidal height exceed 10 feet elevation but are typically less than the original Location 300. Nevertheless, tidal inundation and depth is much greater upstream of the new railroad bridge due to the restored lower elevation of the tidal marsh/embayment. In Figure 7, the yellow star represents the January 25, 2023 date when velocity profiles were measured. Although this date was anticipated to have higher tides, accompanying photos highlight the extent of inundation (also shown in Figure 4).

Figure 7. Post-project hydrograph over five months showing tidal inundation with monthly high tide series. Yellow star is the date of the photographic observations in Figures 4 and 8. Elevation of the embayment at the sensor is 8.68 ft NAVD88.

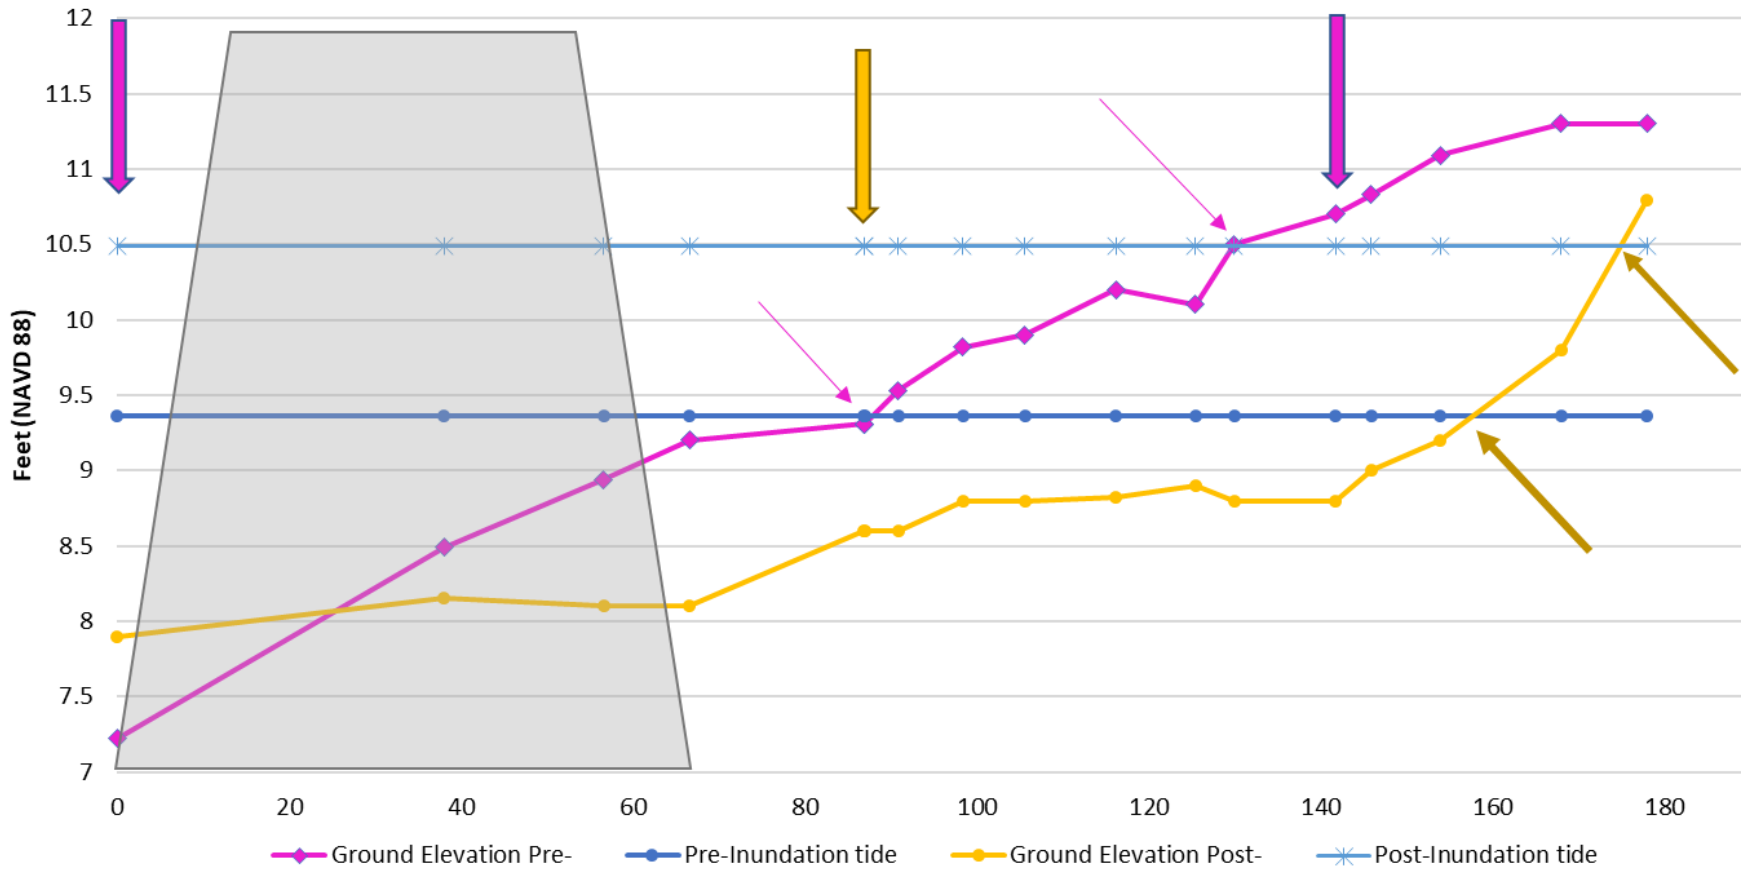
Next, we used the ground elevation from the gauges as well as pre-project and post-project ground surveys to reconstruct a base elevation in the project area according to a longitudinal profile. Figure 9 shows the pre-project and post-project elevation profiles relative to the location of the culvert and two high tidal elevations observed in each sampling period (9.33 ft. and 10.49 ft., respectively). The magenta colored and orange-colored arrows denote the locations of the 2021 (magenta) and 2023 (orange) hydrograph locations along the distance of respective channel centerlines. The magenta line represents the elevation of the streambed in 2021, while orange represents the elevations in 2023. The 2 horizontal lines represent to tidal elevations, and the area under each tidal elevation represents the landward extent (increasing x-axis) and depth of inundation down to the level of each ground profile. Diagonal lines represent the points at which the tidal elevations would meet dry land (for that example tide).

Figure 9. Pre- and post-restoration profile of 2021 (magenta) and 2023 (orange) ground elevations upstream of the railroad culvert (grey trapezoid) with staff gauge locations (block arrows) and elevations of two observed tides and calculated inundation extents (angled arrows).

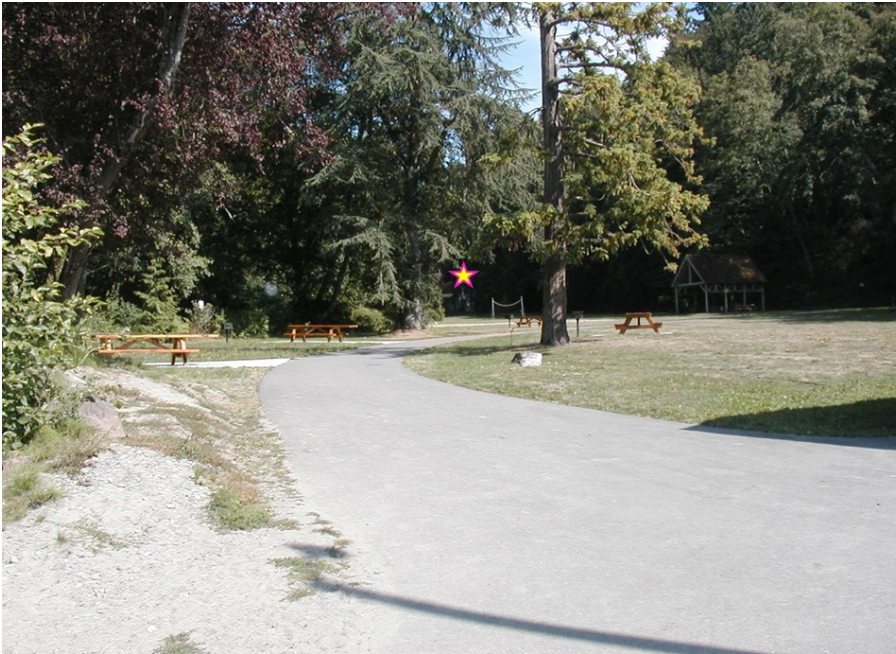
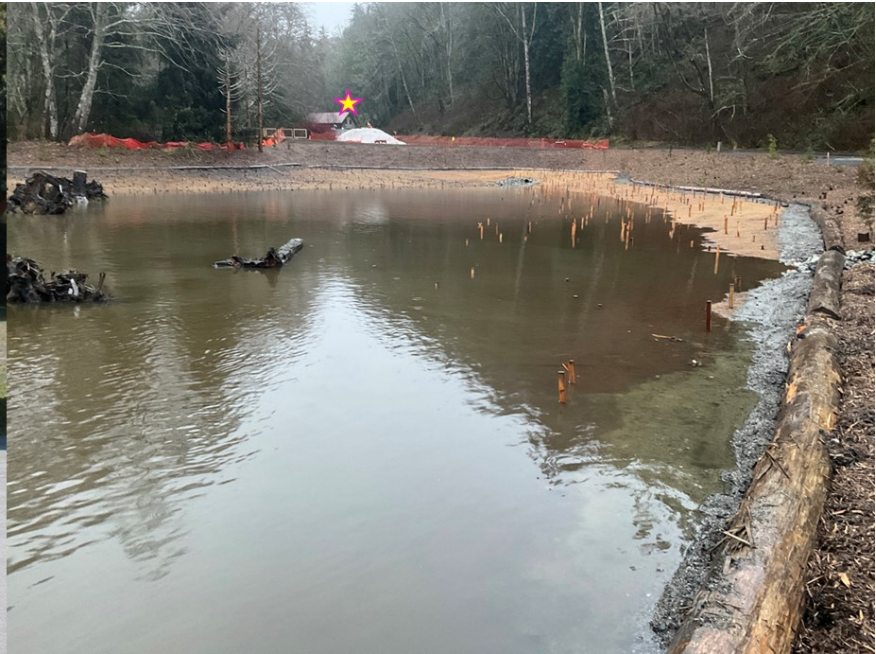
Figure 10. 2004 (left) and 2023 (right) view inland (east) from walkway. The same building in each photo is highlighted with yellow star.

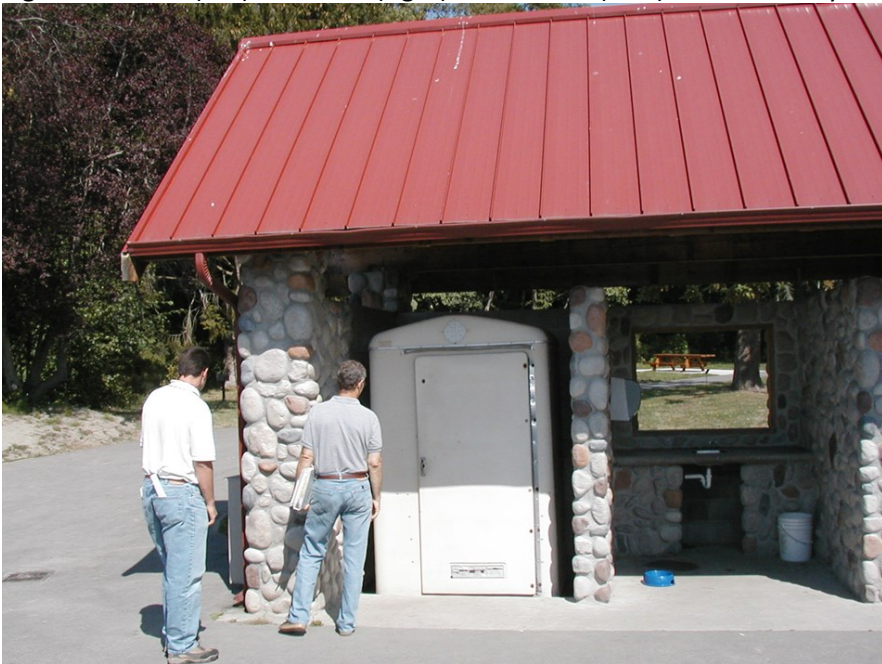
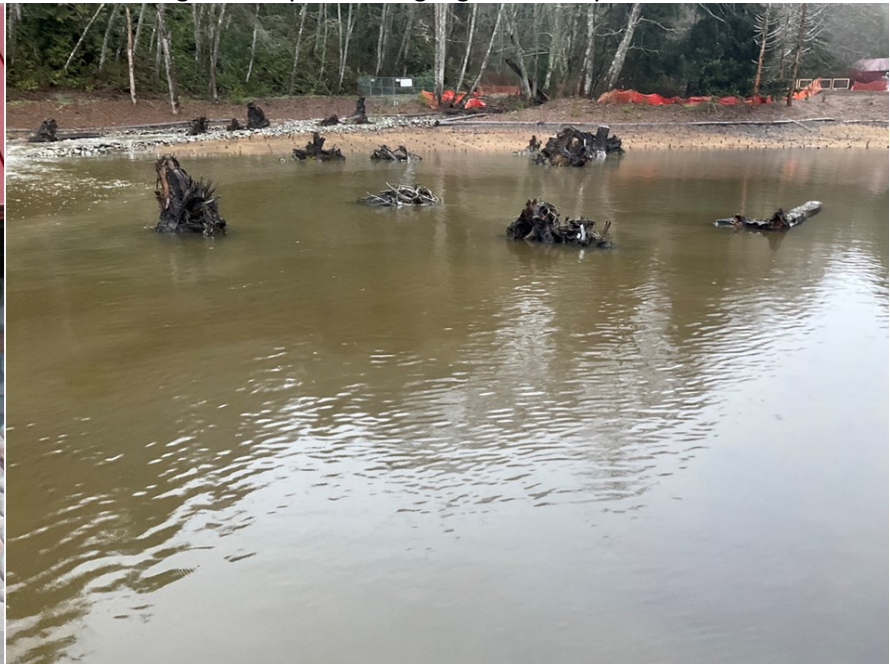
Figure 11. 2004 and 2023 view inland (east) from walkway. The building with red roof in left image is also in the pre-project image in Figure 5.

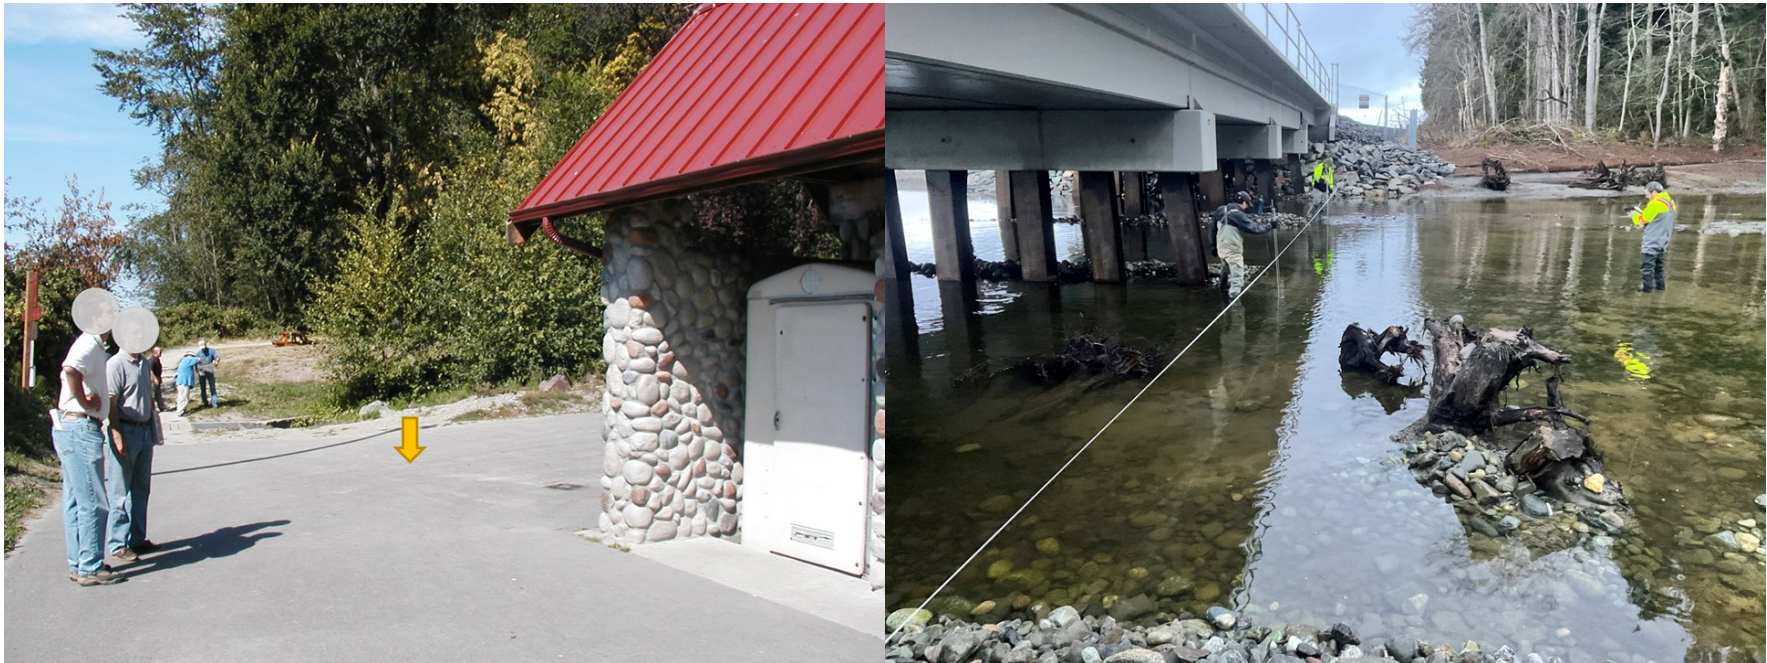
Figure 12. 2004 and 2023 view north. The approximate location of the 2023 hydrograph is marked with orange arrow per Figures 5 and 9.

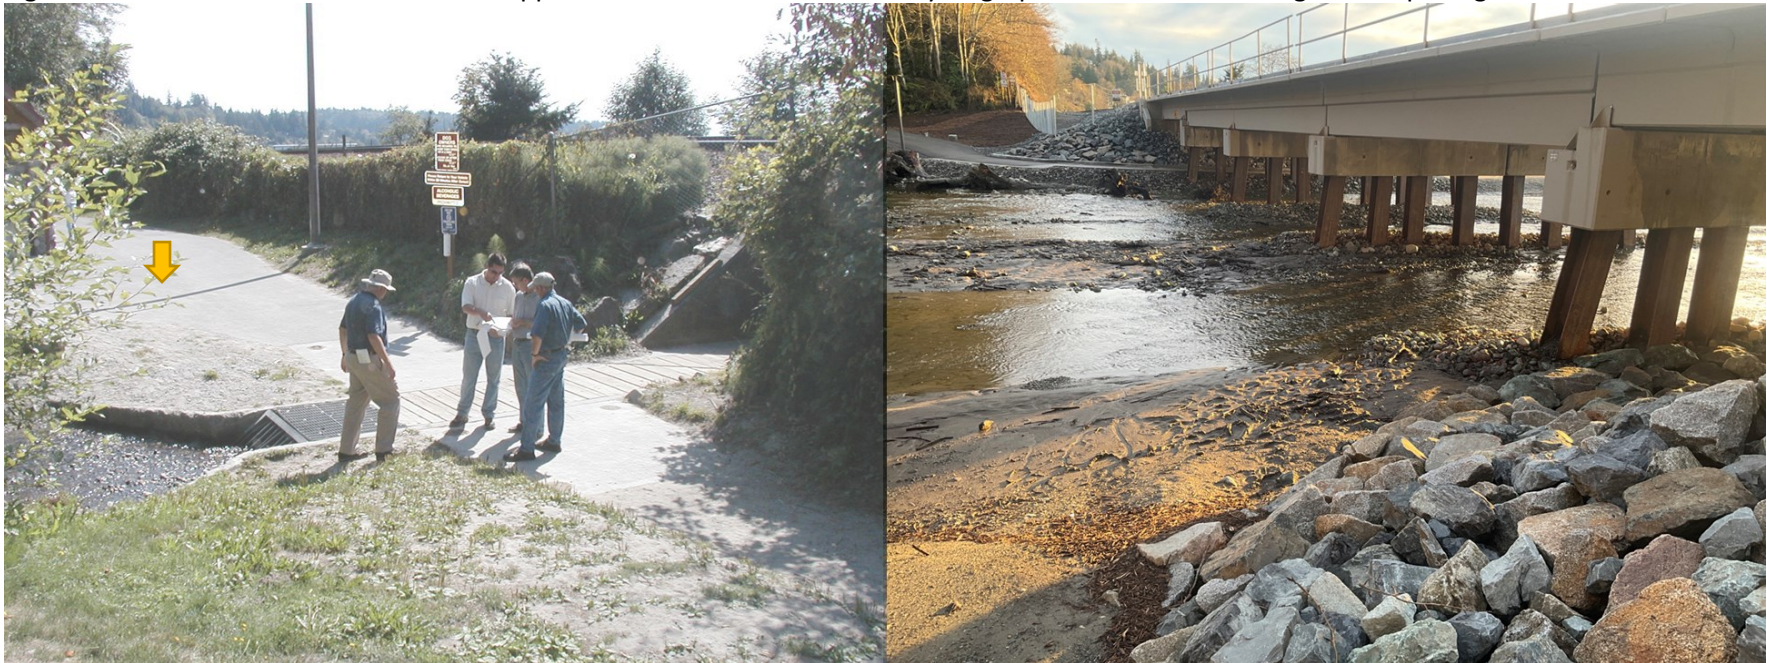
Figure 13. 2004 and 2023 view south. The approximate location of the 2023 hydrograph is marked with orange arrow.

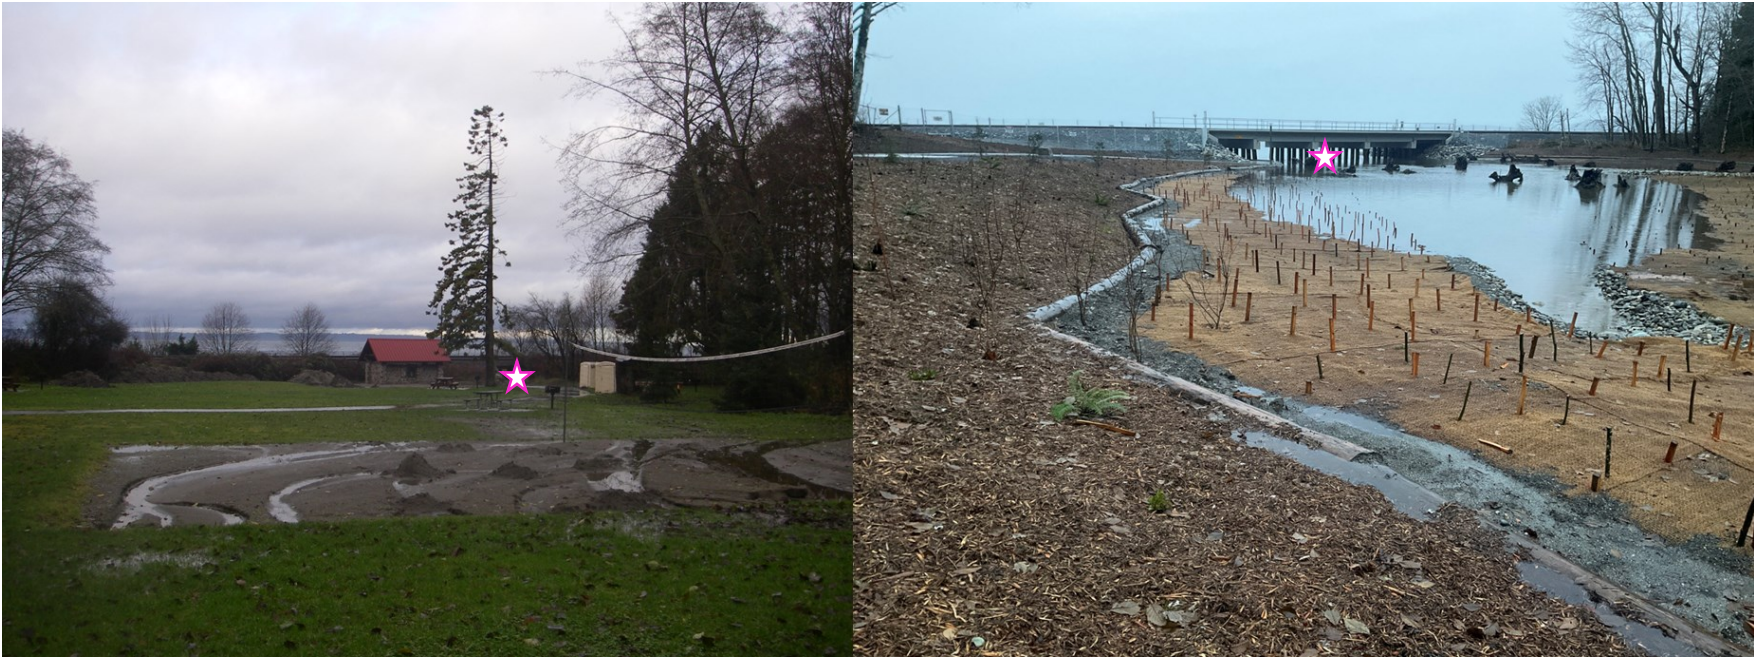
Figure 14. 2004 and 2023 view west. The location of the culvert is marked with a white star.

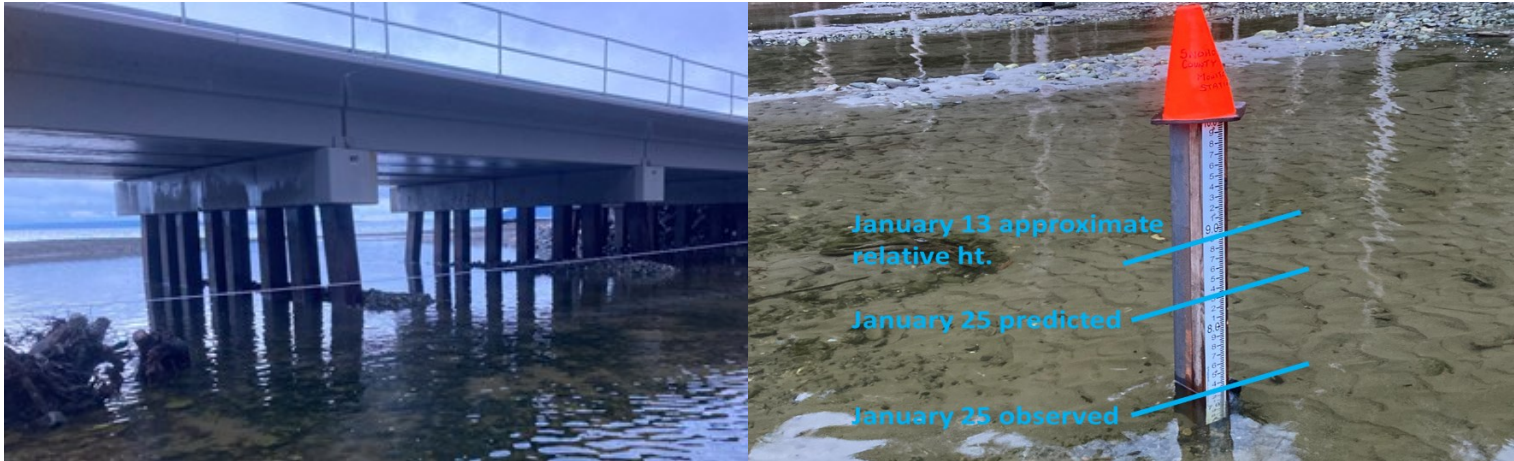
Supplemental Figure S-1. The verified January 25, 2023 tide height at the Seattle station was more than one foot lower than predicted, while the January 13, 2023 tide was actually more than 1.5 feet higher than predicted. This translates into a potential tidal elevation at Meadowdale that might have been approximately 1.63 feet higher than that shown in the inset photo and substantiates the greater tidal inundation of the embayment.
